# Technical Issues Guide

**Digital UHF Wireless System (AT210P Series & DT228 Series)**

Version: 2025.12.12-1

Issued by: infoSVC Corporation

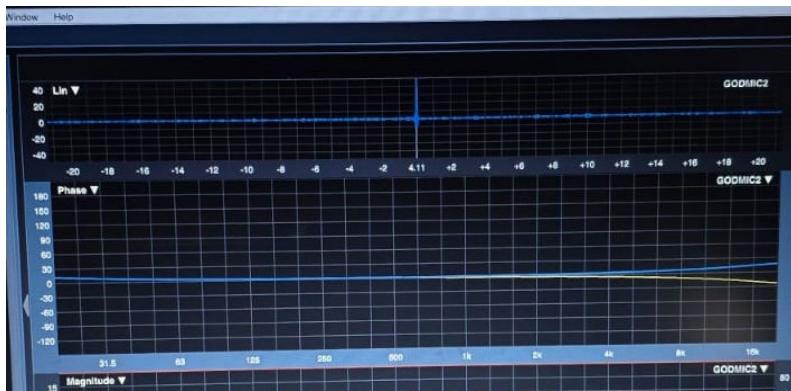
## 5. Two sets of equipment, connected to the same sound source, the phase curves on the test results are inconsistent.

See the figure below.

Phase offset is caused by time difference. The offset is the result of signal phase multiplied by sampling interval multiplied by time difference. The signal source of the sound card output you use is the same, but the sampling time of the two transmitters cannot be the same. Our sampling rate is 48Khz, which means there is 0.02ms between each sampling. The sampling time of the two transmitters cannot be equal. There will be a difference of less than 0.02ms. This time difference will cause the sampling to be at different points in a cycle of the sound wave (corresponding to different phases). This time difference has little effect in the low-frequency area, because the cycle of the low-frequency wave is very long, and the sampling has a slight time difference, which has little effect. However, in the 20Khz area, the difference is very large. If the sampling time difference of the two transmitters is exactly 0.01ms, it can cause a difference of exactly 180 degrees, which causes the phase inconsistency in the high-frequency area.

It is recommended that users sample different delay time inputs for different channels, and gradually adjust the delay time to make the phase curve consistent. If you input the same value for the two channels, the sampling time difference of the two channels will not change at all. Therefore, this phase difference will occur.

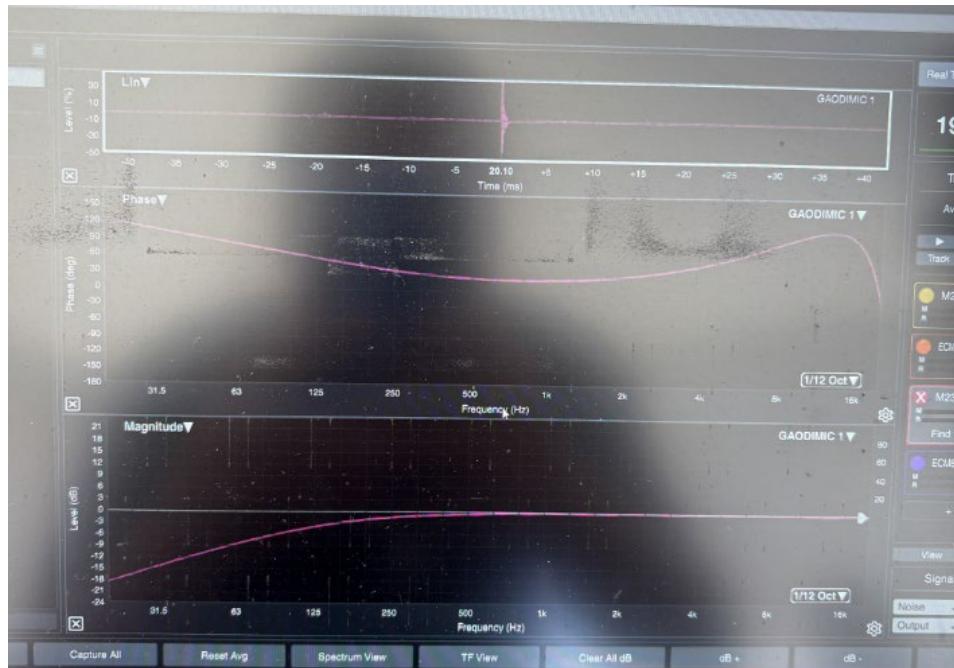
Under normal circumstances, the frequency response attenuation of the AT210P series is less than 2dB, and the frequency response attenuation of the DT228G series is about 3dB. Some customers reported that in actual use, they found that its performance was greater than this value, especially in the low-frequency area.

Some reports which is abnormal with the response from users, like the following pictures:

- Method 1: Check the phantom power of the sound card or mixer, and turn off the phantom power.
- Method 2: Under 24V phantom power conditions, the performance of the device will be better than that of 48V phantom power. In most acoustic measurement situations, you can consider using 24V phantom power, and the results are also acceptable.
